M PROPS (PTY) LTD

Risk Assessment of the Yielding Camlok Prop

Report No. 334822/3

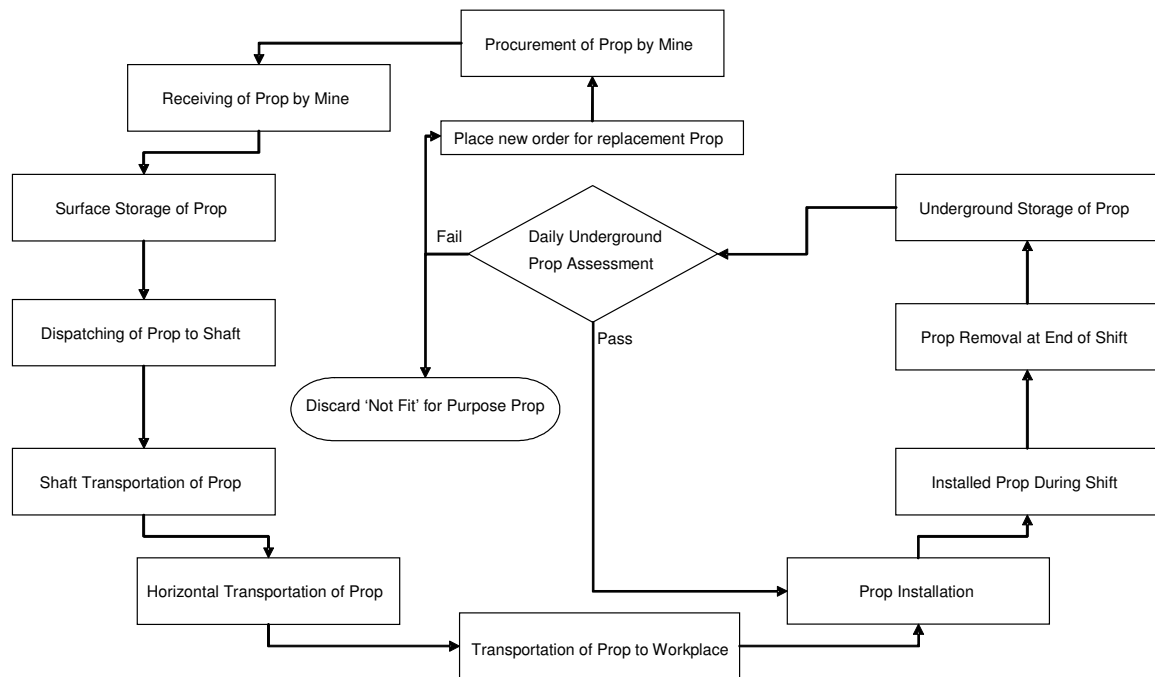
Figure 1: Life Cycle of the Yielding Camlok Prop

The life cycle of a Yielding Camlok Prop starts when an order is received from a mine by M Props for delivery and ends when the prop is declared not fit for purpose due to excessive 'wear and tear' and/or corrosion of the prop and removed from the work place (Figure 1).

The hazards associated with each stage of the life cycle of the Yielding Camlok Prop were discussed and documented by the team during the workshops. Conclusions from these discussions are described for each stage of the life cycle, where the main risks associated with the use of a Yielding Camlok Prop are highlighted. The full risk assessment can be found in Appendix B.

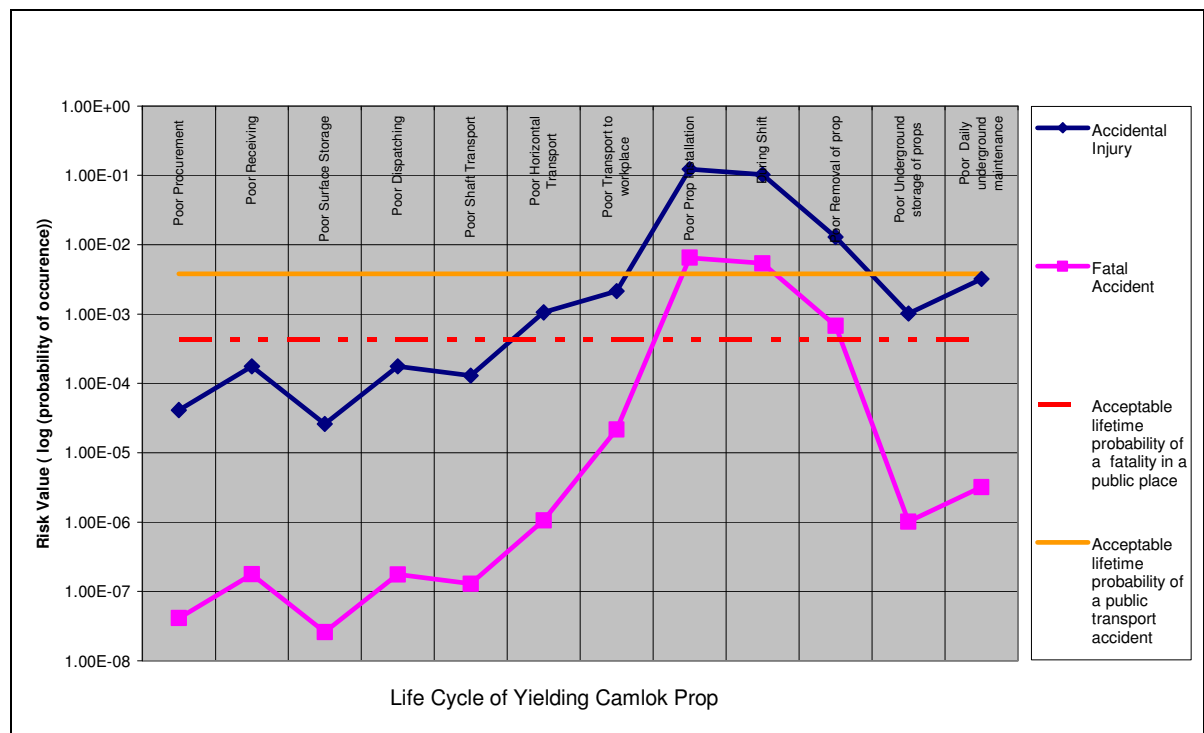
Figure 2: Risk profile of the Yielding Camlok Prop

The probability of occurrence of the top fault, the threat to mine personnel while using the Yielding Camlok Prop is calculated for each identified stage of the life cycle. From this the probability of a mine employee being injured or fatally injured can be calculated taking into account their exposure time and the potential severity of the hazard (Figure 2).

From this risk profile, it is clear that the risk of injury to mine personnel increases as the prop progresses through its life cycle towards the workplace and decreases after the prop has been removed from the workplace and stored for the next shift.

Figure 2 shows a significant increase in the risk profile as the Yielding Camlok Prop enters the workplace. The indicated benchmarks are the acceptable lifetime probability of total loss in a public place and while using public transport (Cole, 1993). The probability of a fatal injury to mine personnel while using a Yielding Camlok Prop remains within acceptable limits, except for the installation, during the shift and removal of the prop. However, a mine employee trained in the correct use of the Yielding Camlok Prop should be aware of the hazards and risks associated with his/her daily tasks underground, making them more vigilant thus reducing the risk to themselves when compared to a general member of the public with a low awareness and little ability to reduce the risk of being fatally injured in a public place or on public transport.

A risk profile is compiled for the life cycle, where the threat of injury to mine personnel is determined by calculating the probability of injuries or fatal injuries occurring to mine personnel, taking into account the exposure of mine personnel to the hazards and the severity of the hazard. These probabilities are benchmarked against acceptable lifetime probabilities of being fatally injured in a public place or on public transport (Cole, 1993).

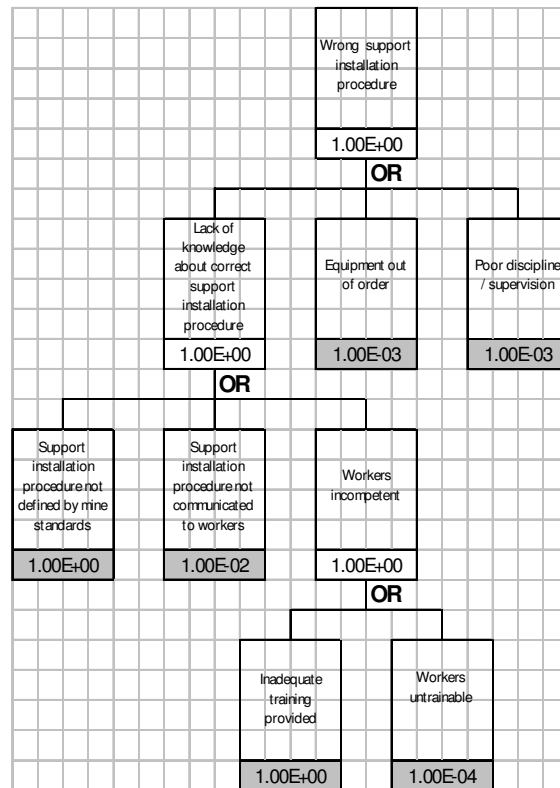
The probability of a wrong support installation procedure being used could be different for different parts or sections of the mine. For example, the equipment being used for support installation in one section could be more reliable than the equipment being used in another section.

The probability of a wrong support installation procedure being used can be represented as follows:
